CDFG, 1995

STREAM INVENTORY REPORT

Stover Creek

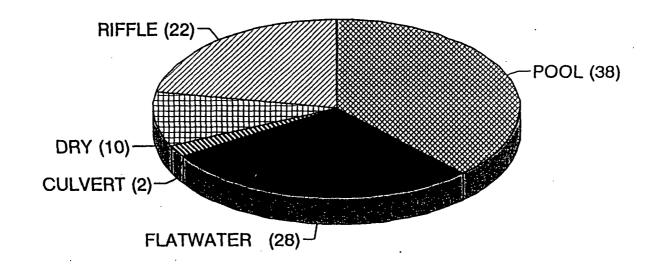
STOVER CREEK HABITAT TYPES BY PERCENT OCCURRENCE

Table 1 summarizes the Level II riffle, flatwater, pool, dry, and culvert habitat types. Based on frequency of occurrence there were 22% riffle units, 28% flatwater units, 38% pool units,

10% was dry, and was 2% culvert units (Graph 1). Based on total **length** of Level II habitat types there were 17% riffle units, 34% flatwater units, 32% pool units, 8% was dry, and 9% was culvert units (Graph 2).

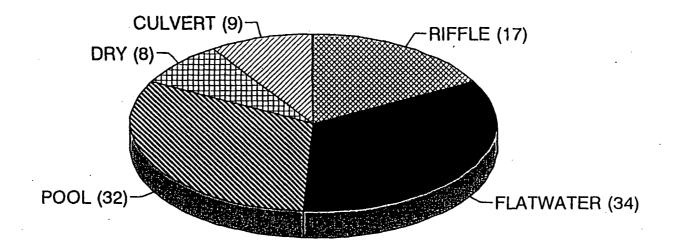
STOVER CREEK HABITAT TYPES BY PERCENT TOTAL LENGTH

Flatwater habitat types comprised 34% of the total length of this survey, riffles 17%, and pools 32%. The pools are relatively shallow, with none of the 19 pools having a maximum depth greater than 2 feet. In general, pool enhancement projects are considered when primary pools comprise less than 40% of the length of total stream habitat. In first and second order streams, a primary pool is defined to have a maximum depth of at least two feet, occupy at least half the width of the low flow channel, and be as long as the low flow channel width. Installing structures that will deepen pool habitat is recommended for locations where their installation will not be threatened by high stream energy.

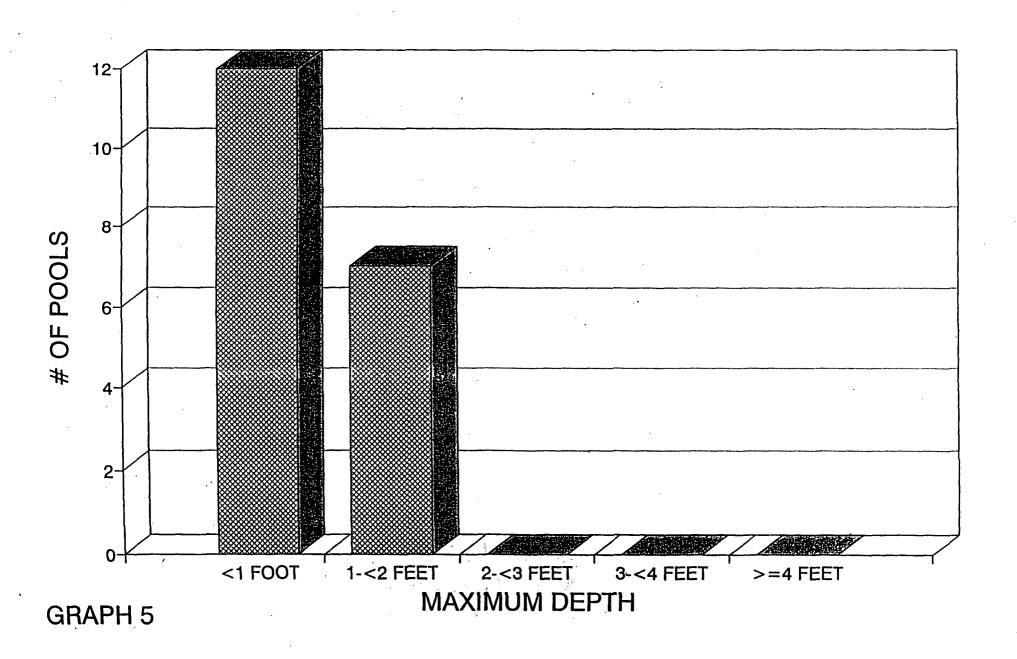
STOVER CREEK MAXIMUM POOL DEPTHS

Table 4 is a summary of maximum pool depths by pool habitat types. Pool quality for salmonids increases with depth. None of the nineteen pools (0%) had a depth of two feet or greater (Graph 5).

- Where feasible, design and engineer pool enhancement structures to deepen existing pools. Although A3 channel types are generally not suitable for pool enhancement structures there may be specific appropriate sites on Stover Creek. This must be done where the banks are stable or in conjunction with stream bank armor to prevent erosion.

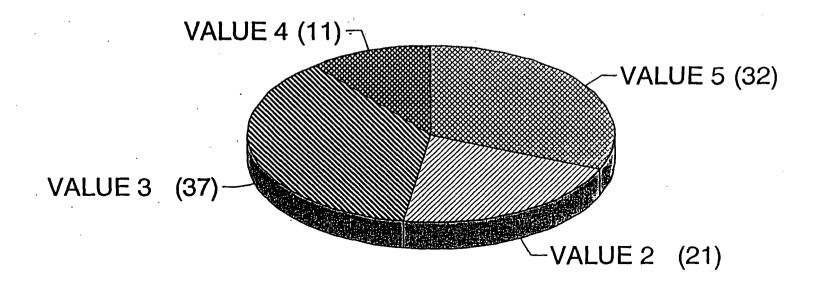
STOVER CREEK PERCENT EMBEDDEDNESS

The depth of cobble embeddedness was estimated at pool tail-outs. Of the nineteen pool tail-outs measured, none had a value of 1 (0%); 4 had a value of 2 (21%); 7 had a value of 3 (37%); 2 had a value of 4 (11%) and 6 had a value of 5 (32%) (Graph 6). On this scale, a value of 1 indicates the highest quality of spawning substrate.

Fifteen of the nineteen pool tail-outs measured had embeddedness ratings of 3, 4 or 5. No pools had a 1 rating. Cobble embeddedness measured to be 25% or less, a rating of 1, is considered to indicate good quality spawning substrate for salmon and steelhead. In Stover Creek, sediment sources should be mapped and rated according to their potential sediment yields, and control measures should be taken.

- 4) Inventory and map sources of stream bank erosion and prioritize them according to present and potential sediment yield.
- 5) Active and potential sediment sources related to the road system need to be identified, mapped, and treated according to their potential for sediment yield to the stream and its tributaries.

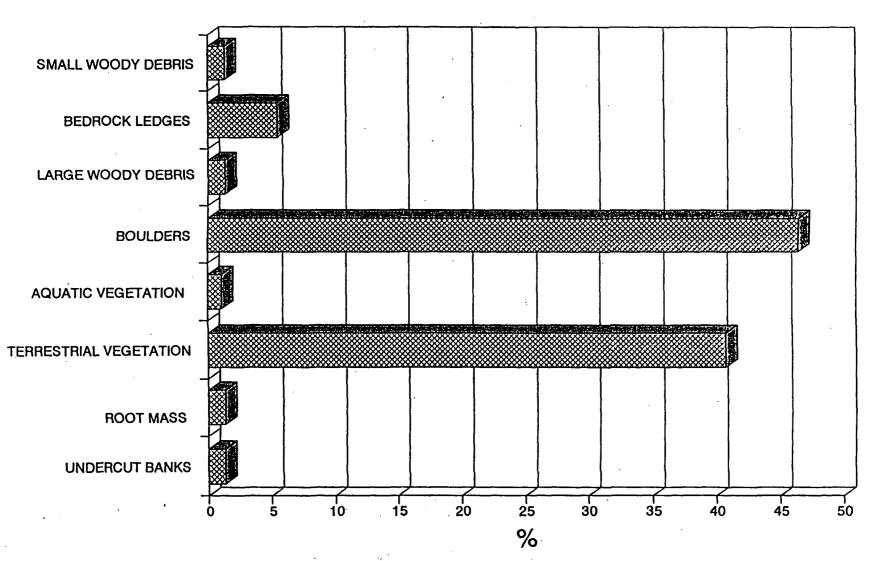
STOVER CREEK MEAN PERCENT COVER TYPES IN POOLS

Table 5 summarizes mean percent cover by habitat type. Boulders are the dominant cover type in Stover Creek. Graph 7 describes the pool cover in Stover creek.

The mean shelter rating for pools was low with a rating of 21. The shelter rating in the flatwater habitats was slightly better at 36. A pool shelter rating of approximately 100 is desirable. The relatively small amount of cover that now exists is being provided primarily by boulders in all habitat types. Additionally, terrestrial vegetation contributes a small amount. Log and root wad cover structures in the pool and flatwater habitats are needed to improve both summer and winter salmonid habitat. Log cover structures provide rearing fry with protection from predation, rest from water velocity, and divides territorial units to reduce density related competition.

- 3) Increase woody cover in the pools and flatwater habitat units. Most of the existing cover is from boulders. Adding high quality complexity with woody cover is desirable and in some areas the material is locally available.

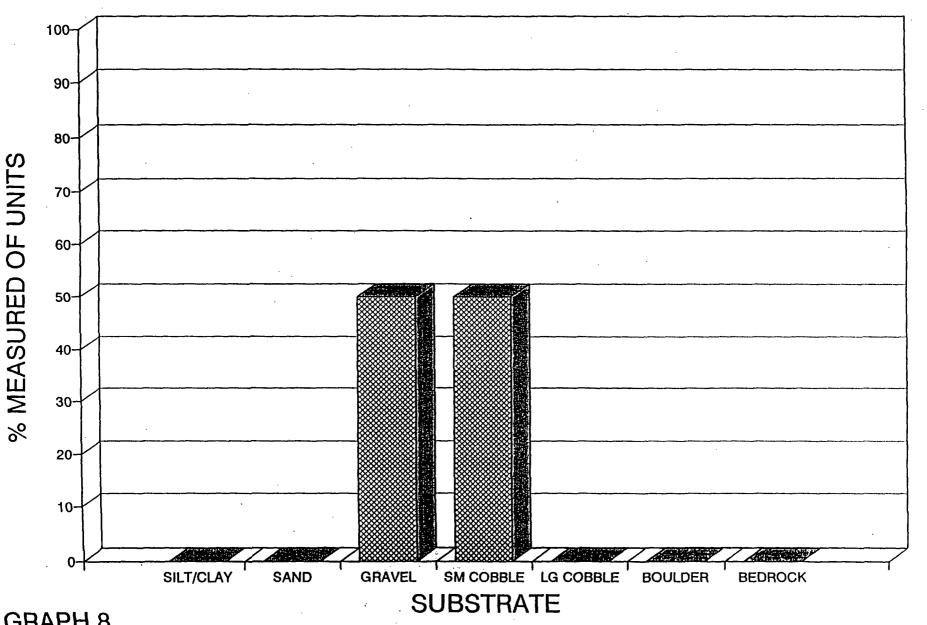
GRAPH 8

Table 6 summarizes the dominant substrate by habitat type. Gravel was observed in 2 of the 4 low gradient riffles (50%) and small cobble was equally observed in 2 of the 4 low gradient riffles measured (50%). (Graph 8).

All of the low gradient riffles measured had gravel or small cobble as the dominant substrate. This is generally considered good for spawning salmonids.

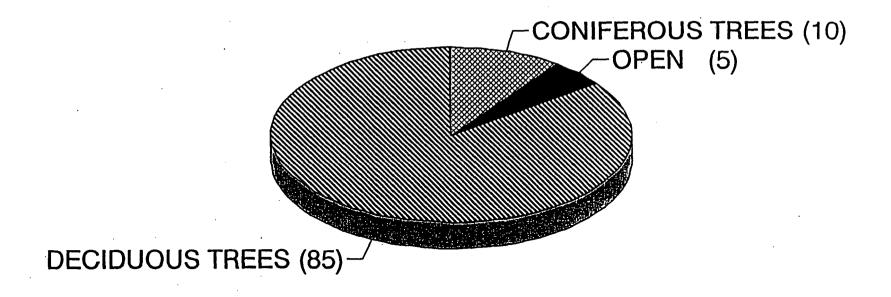
STOVER CREEK PERCENT CANOPY

The mean percent canopy density for the stream reach surveyed was 95%. The mean percentages of deciduous and coniferous trees were 89% and 11%, respectively. Graph 9 describes the canopy in Stover Creek.

The mean percent canopy density for the stream was 95%. This is a relatively high percentage of canopy. In general, revegetation projects are considered when canopy density is less than 80%.

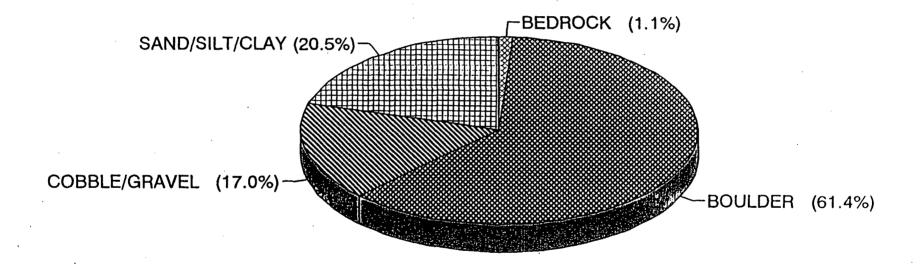
DOMINANT BANK COMPOSITION IN SURVEY REACH

For the stream reach surveyed, the mean percent right bank vegetated was 34.7%. The mean percent left bank vegetated was 35.9%. The dominant elements composing the structure of the stream banks consisted of 1.09% bedrock, 58.7% boulder, 16.3% cobble/gravel, and

19.57% sand/silt/clay (Graph 10). Grass was the dominant vegetation type observed in 56.52% of the units surveyed. Additionally, 807% of the units surveyed had deciduous trees as the dominant vegetation type, and 0% had coniferous trees as the dominant vegetation, including downed trees, logs, and root wads (Graph 11).

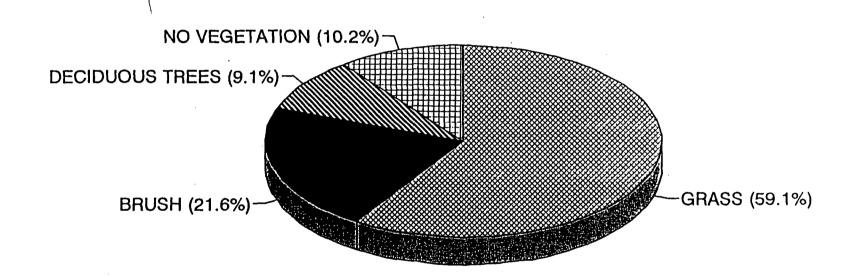
DOMINANT BANK VEGETATION IN SURVEY REACH

The percentage of right and left bank covered with vegetation was low at 34.7% and 35.9%, respectively. In areas of stream bank erosion or where bank vegetation is not at acceptable levels, planting endemic species of coniferous and deciduous trees, in conjunction with bank stabilization, is recommended.
